## **CAFO FACILITY INSPECTION REPORT**

<b>Inspection Date:</b>	<b>March 26, 2014</b>
<b>Facility Name:</b>	<b>Armstrong Egg Farms</b>
<b>Facility Address:</b>	<b>(b) (6)</b>
<b>Authorized Official &amp; Phone:</b>	<b>Ryan Armstrong, VP Operations, (M) 7 [REDACTED]</b>
<b>Mailing Address of Authorized Official:</b>	<b>P.O. Box 2299 Valley Center, CA 92082</b>
<b>NPDES #:</b>	<b>Unpermitted</b>
<b>On-Site Representative &amp; Phone:</b>	<b>Ryan Armstrong, VP Operations (M) 7 [REDACTED] 5/ (O) 760-749-1058</b>
<b>Receiving Water(s):</b>	<b>Not yet determined at time of inspection.</b>
<b>Inspector(s)</b>	<b>Kristine Karlson, EPA Region 9 - 415-947-4297 Michelle Mata, San Diego Water Quality Control Board (SDWQCB) - 619-521-3369 Dat Quach, SDWQCB - 619-521-5899</b>

Armstrong Chicken Farms Clean Water Act inspection (\_\_\_ of 88 photos)  
All photos taken by Kristine Karlson, EPA, on March 26, 2014.

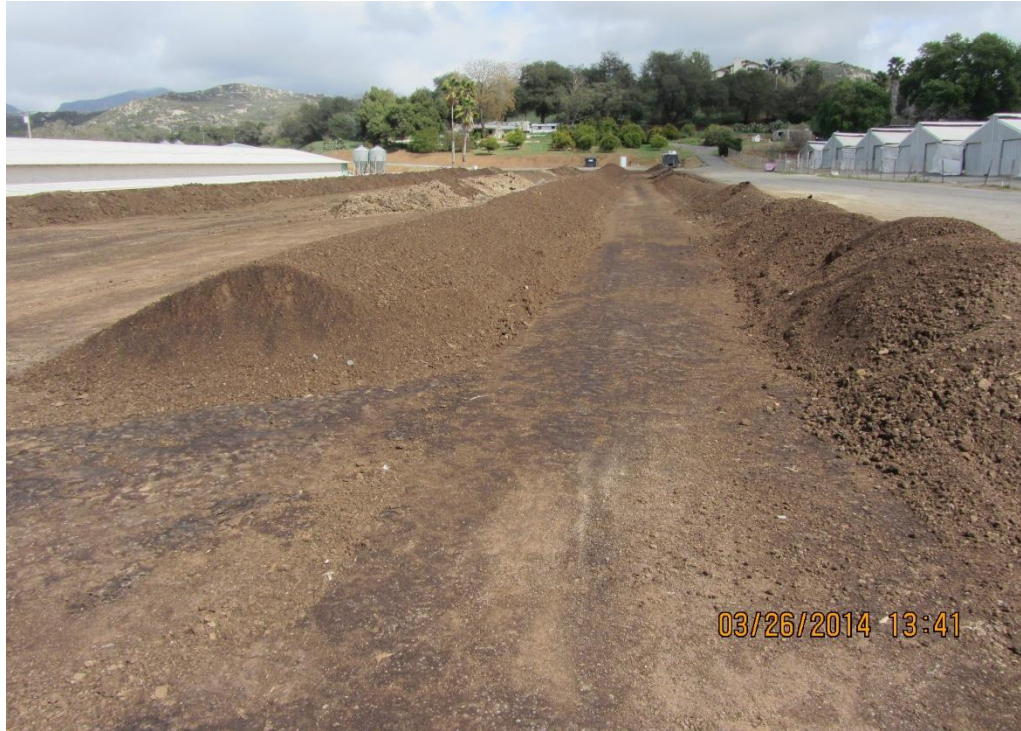
Photo 16 – Closer view of the manure piles stored in the center of the site. These were previously shows in Photos 5, 6 and 14.

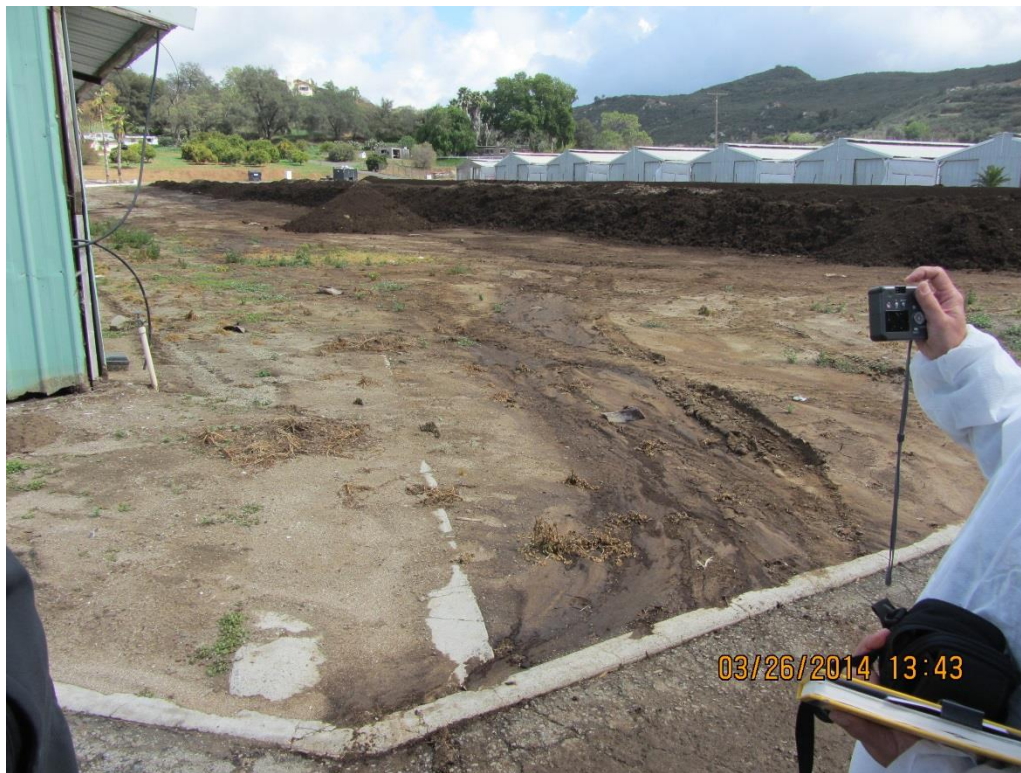
Photo 17 – This unpaved area to the north of the manure piles contains manure runoff rills. The rills and topography show that the direction of the runoff is to the northwest, and then back onto the paved area along the western border of the facility.

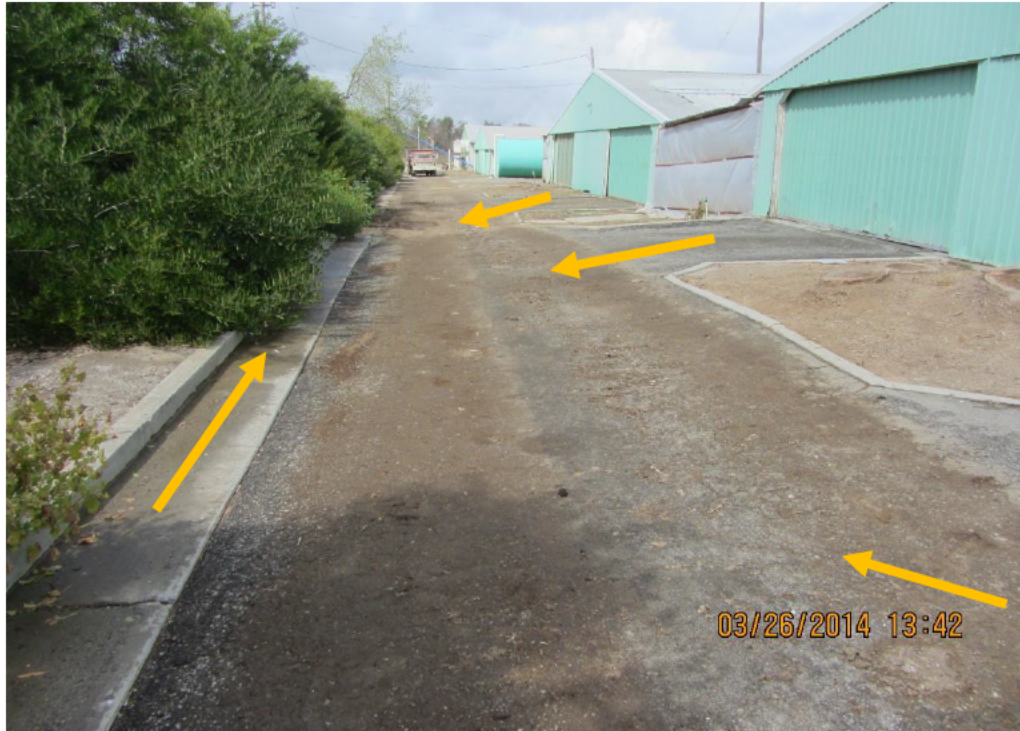
Photo 18 – View toward the north along the paved western border of the facility. According to Mr. Armstrong, the curb to the left keeps flows moving toward the discharge point near the NW corner. Arrows show reported direction of flow.

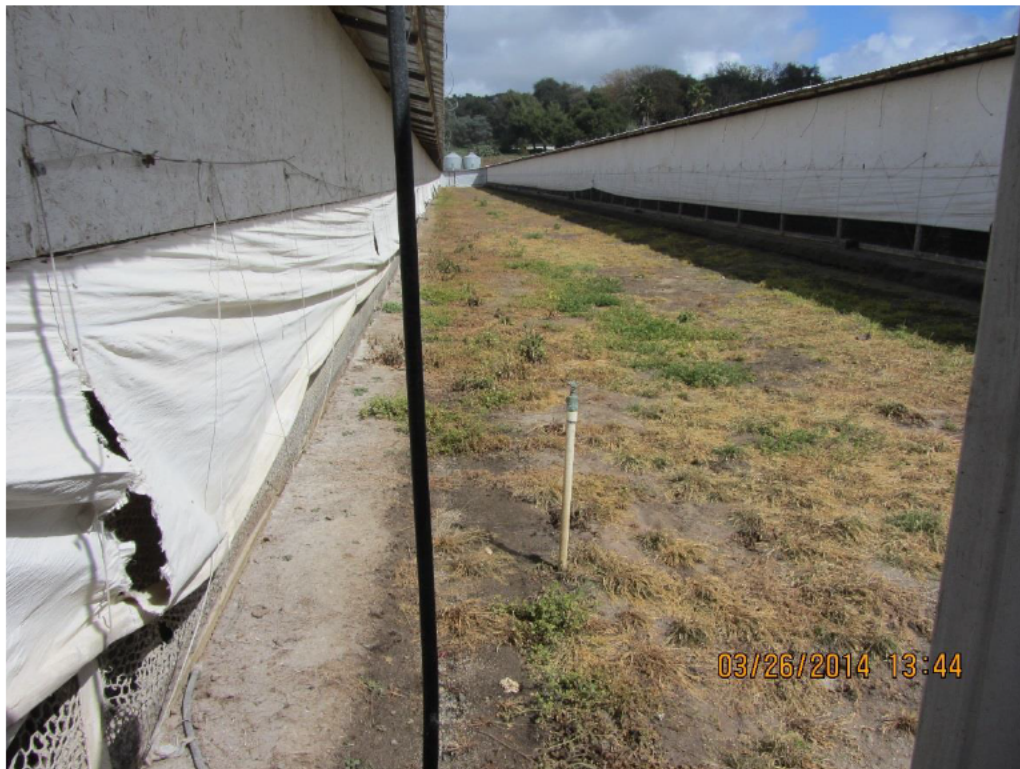
Photo 19 – View of the area between hen houses in the northwest quadrant of the facility.

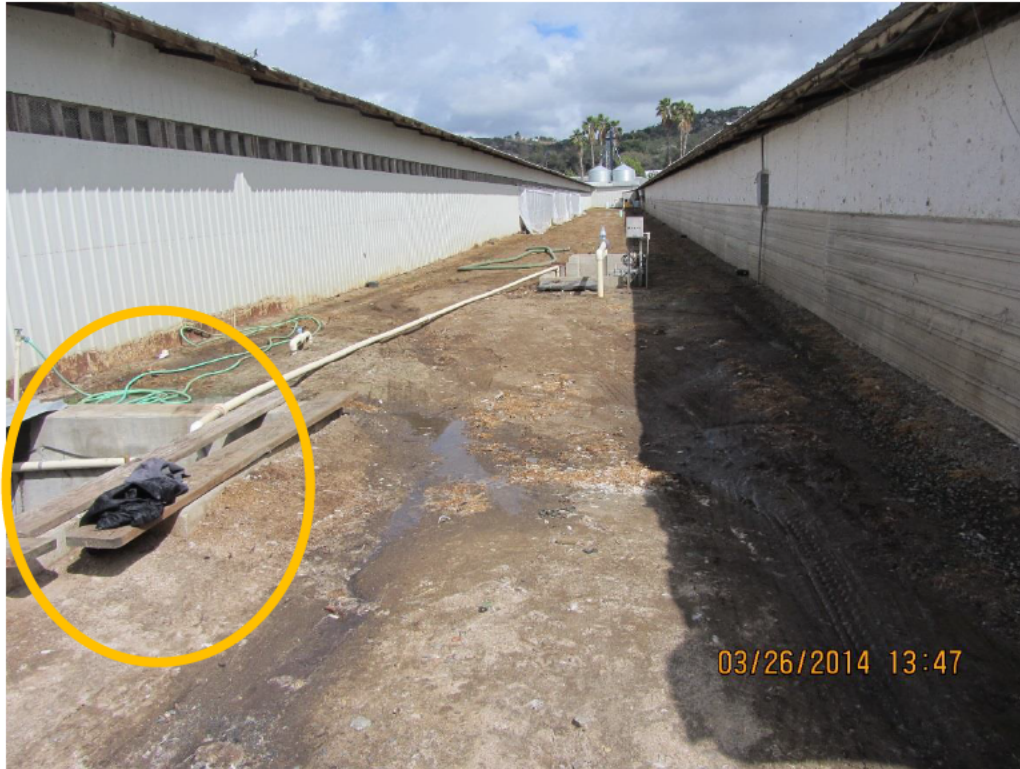
Photo 20 – View between the last two hen houses in the northwest quadrant of the facility. Areas are eroding, and there are feathers on the ground. On the left (marked) is a manure cleanout.

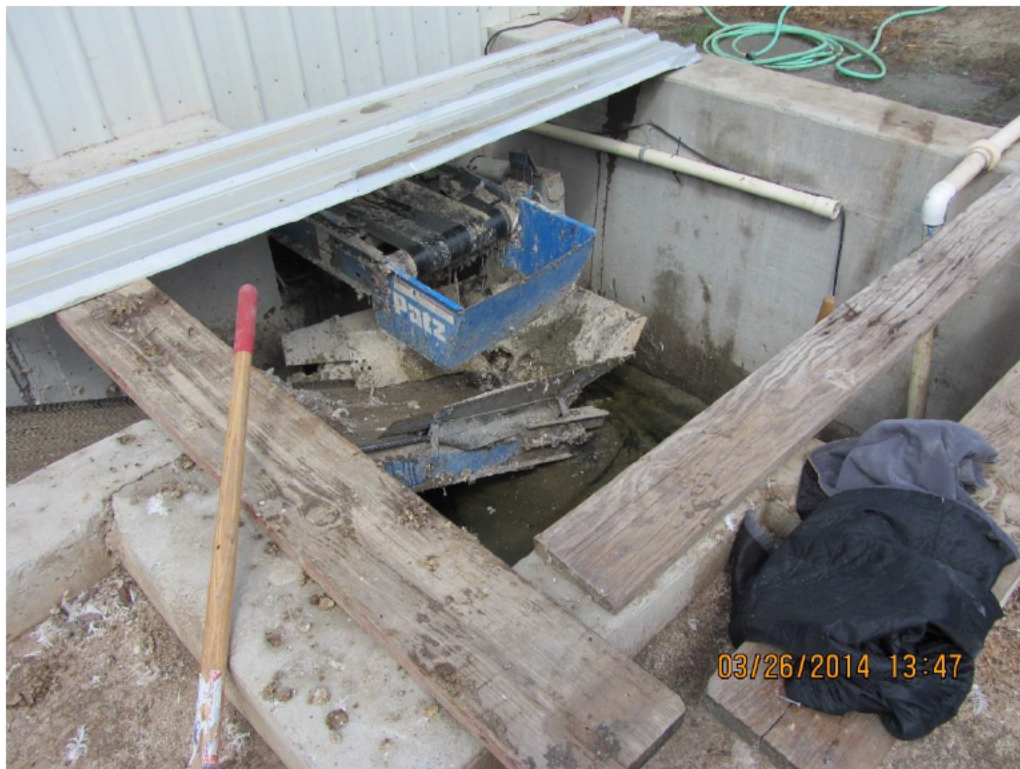
Photo 21 – Closer view of manure cleanout in previous photo.

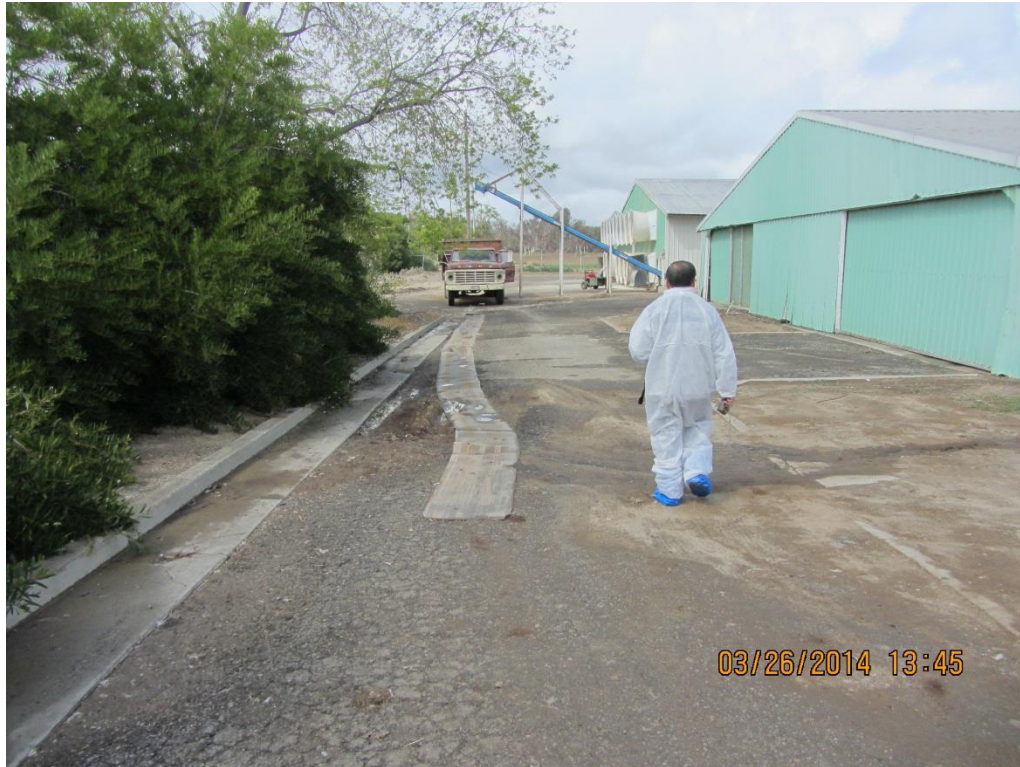
Photo 22 – Toward the end of the curb seen in Photo 18. Ahead, a blue conveyor belt is visible, loading manure from the cleanout in Photos 20 and 21 into the back of the red truck.

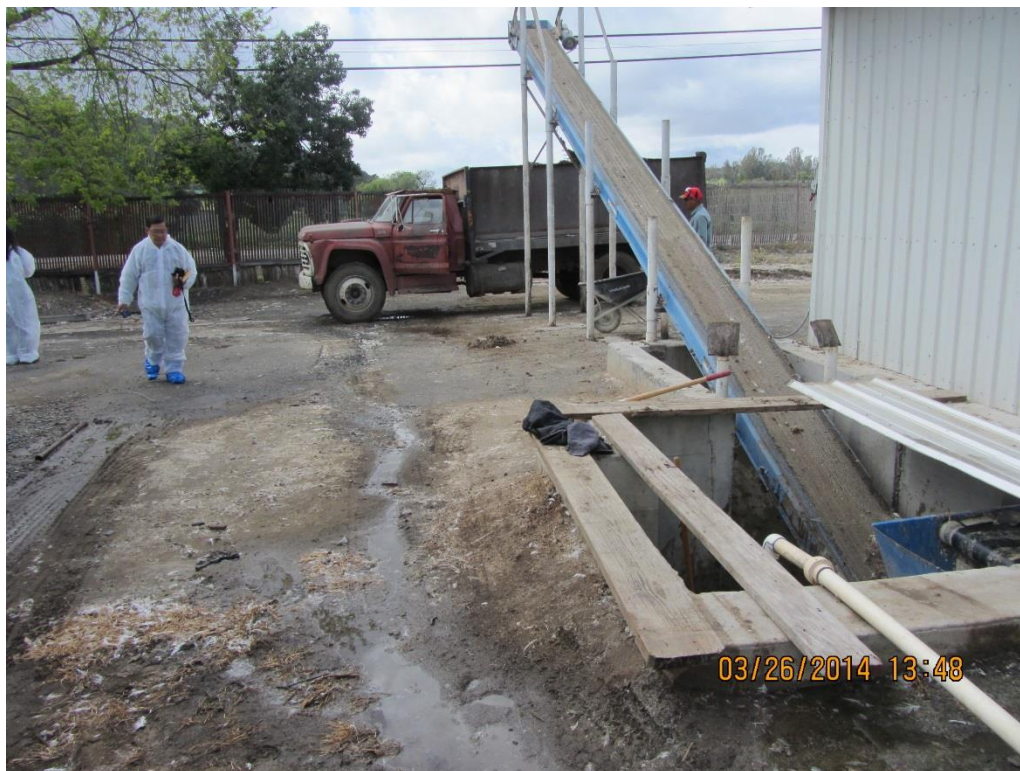
Photo 23 – View of conveyor belt unloading manure into the red truck in Photo 22. Manure is spilled on the pavement.

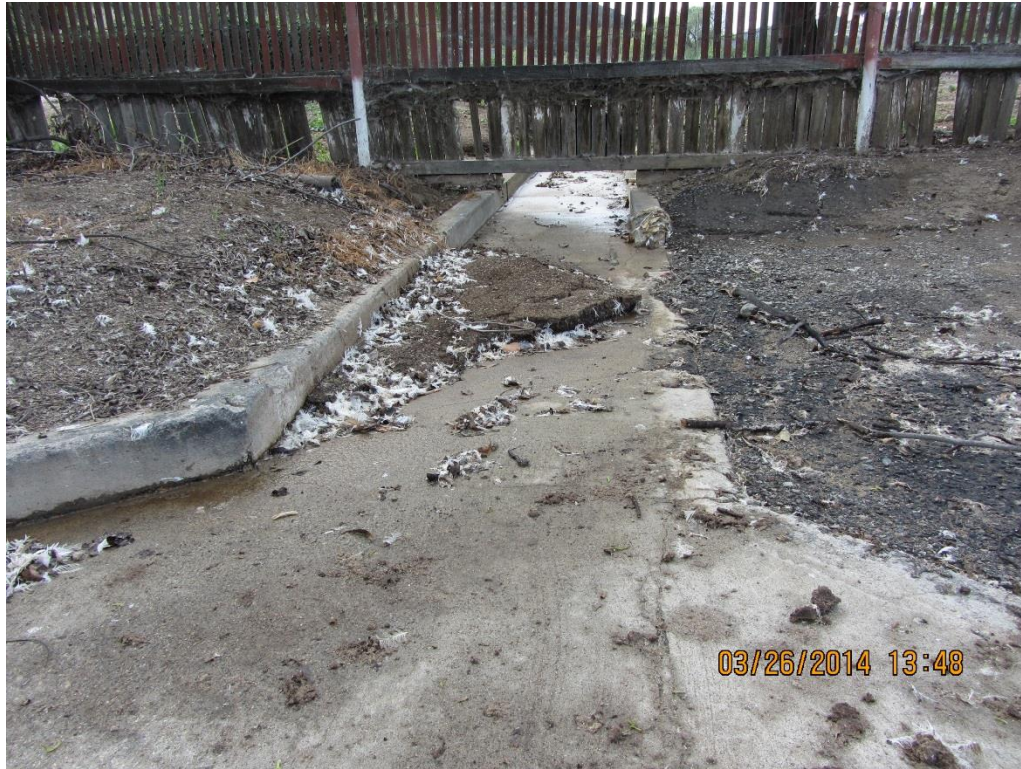
The discharge point near the northwest corner consists of a concrete curb leading to a funnel-shaped headwall at the inlet of a culvert that directs flows west under N. Lake Wohlford Rd. At the outlet of the culvert is an earthen ditch

Photo 25 – Closer view of discharge point seen in previous photo. A cement channel leads under the fence line to the west. Feathers and other debris has accumulated here.

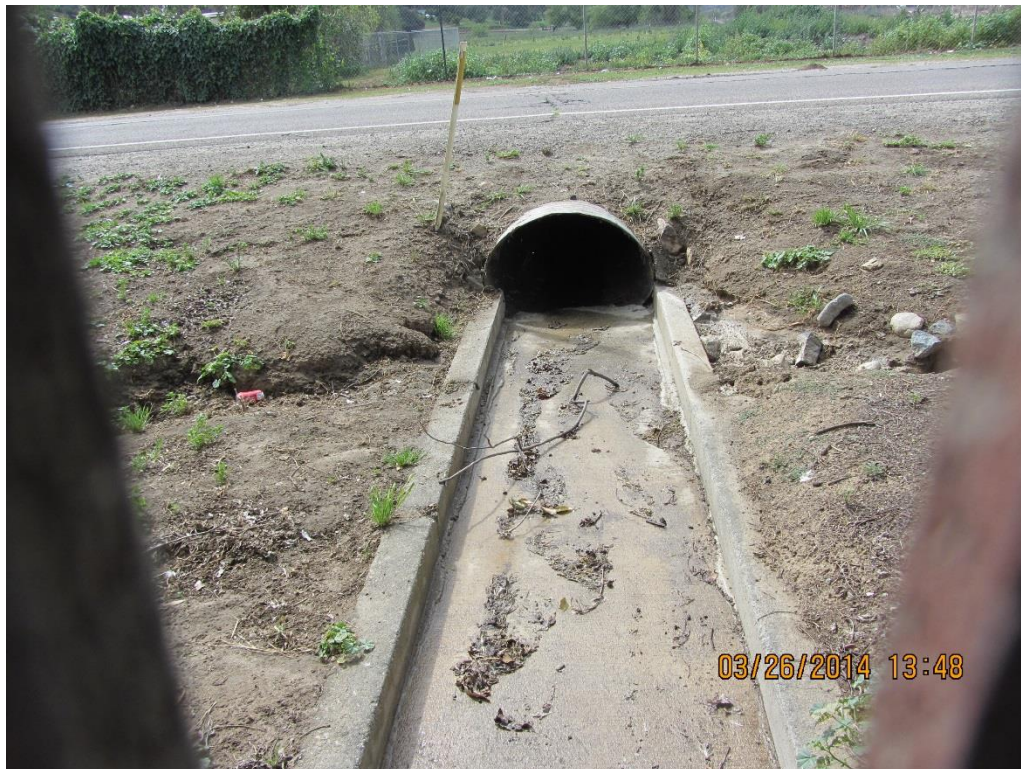
Photo 26 – View through the fence of the cement channel, as it enters a culvert that crosses under North Lake Wohlford Rd.

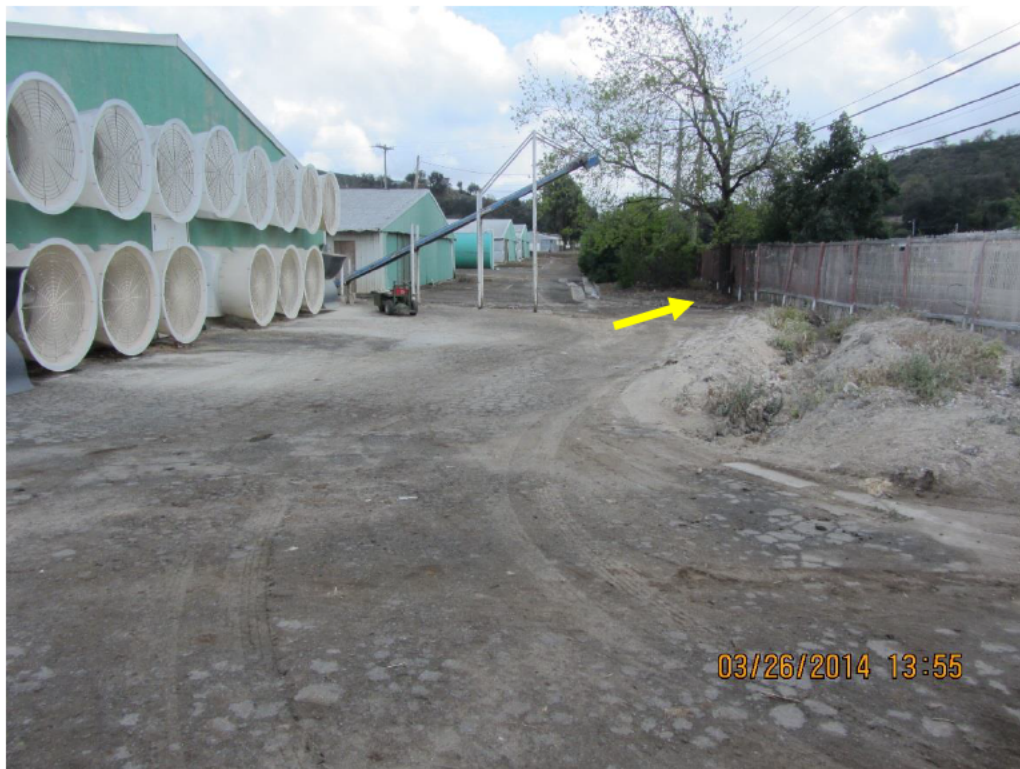
Photo 28 – Blowers airing out the largest hen house, at the NW corner of the facility. The light coloring on the ground is a coating of fine feathers. Discharge point is marked with an arrow.

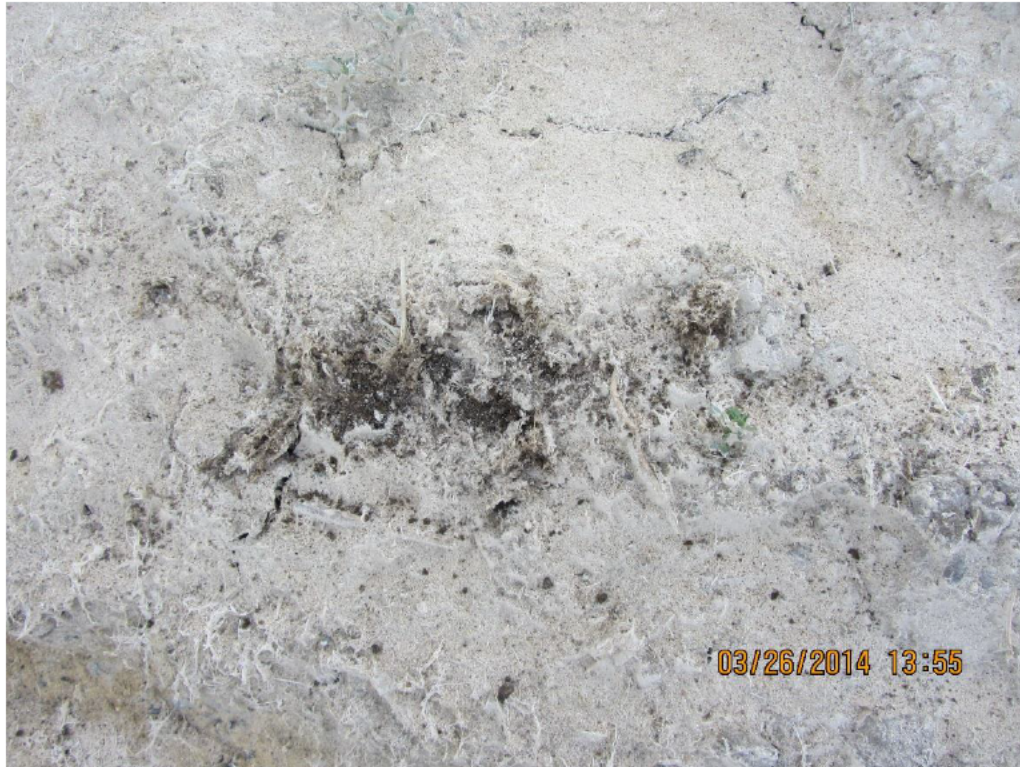
Photo 29 – Feathers coating the ground outside the hen house in the previous photo. Inspector Kristine Karlson kicked the surface of the coating to show the contrast with the darker ground underneath.

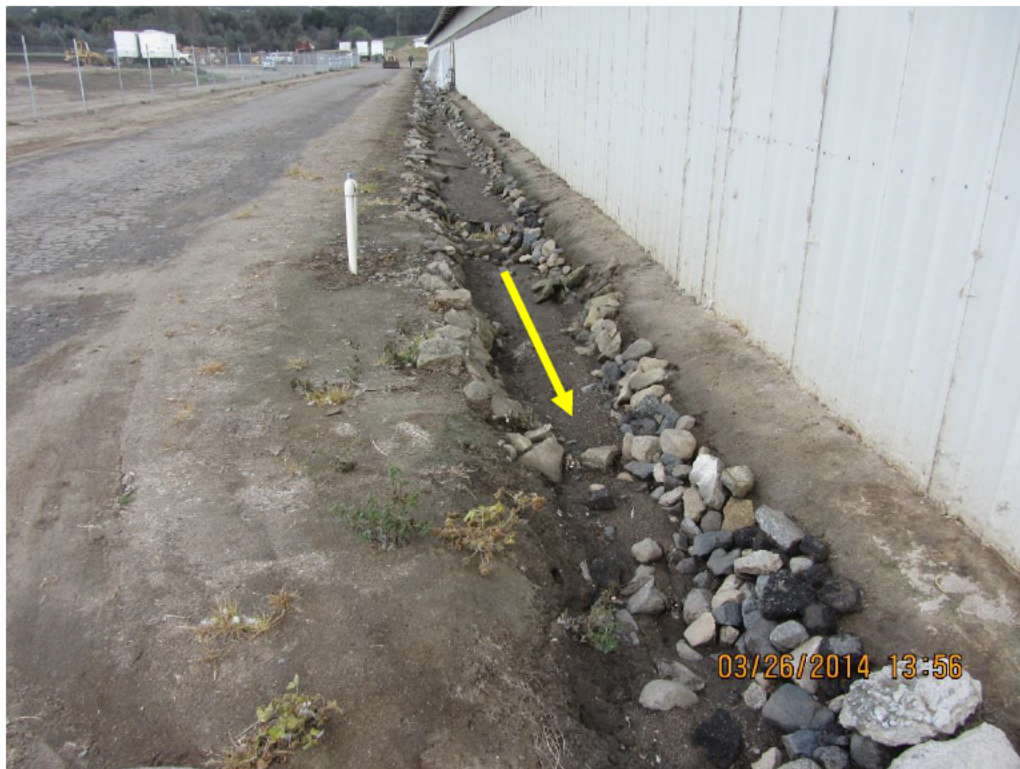
Photo 30 – View to the east of runoff channel alongside the north side of the hen house in Photo 28. Direction of flow, per Mr. Armstrong, is to the west and toward the discharge point (see arrow).

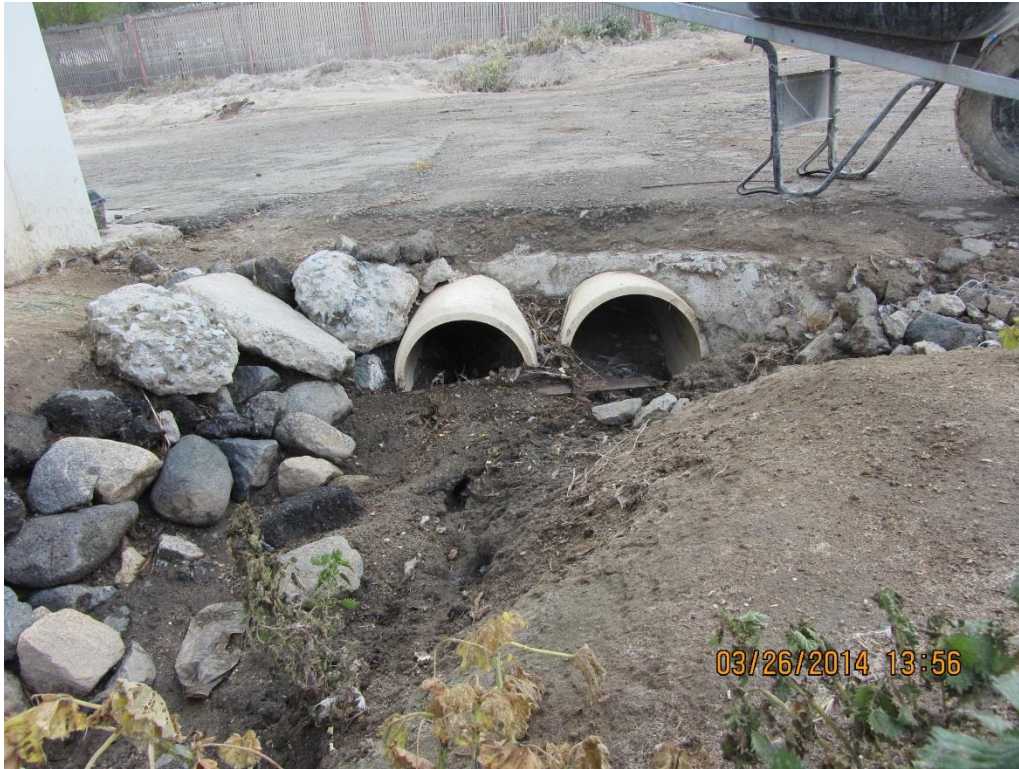
Photo 31 – These pipes convey flows from the channel in the previous photo under the access road along the west side of the facility.

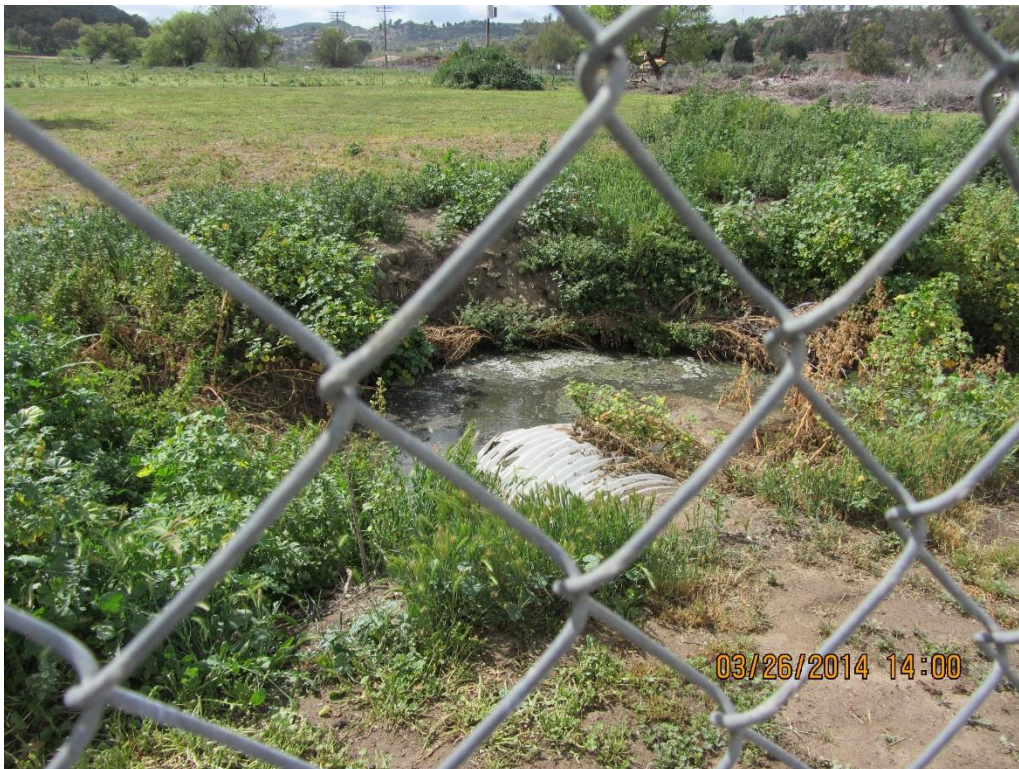
that turns sharply toward the north, then bends west. The ultimate destination of flows that enter the ditch is not apparent from the roadway. Mr. Armstrong claims to be leasing this property that receives the Site's discharges.

Photo 32 – Outlet of culvert seen in Photo 26. It discharges to the west, into a drainage channel to the west of North Lake Wohlford Rd. Mr. Armstrong said that he leases this property from the owner.

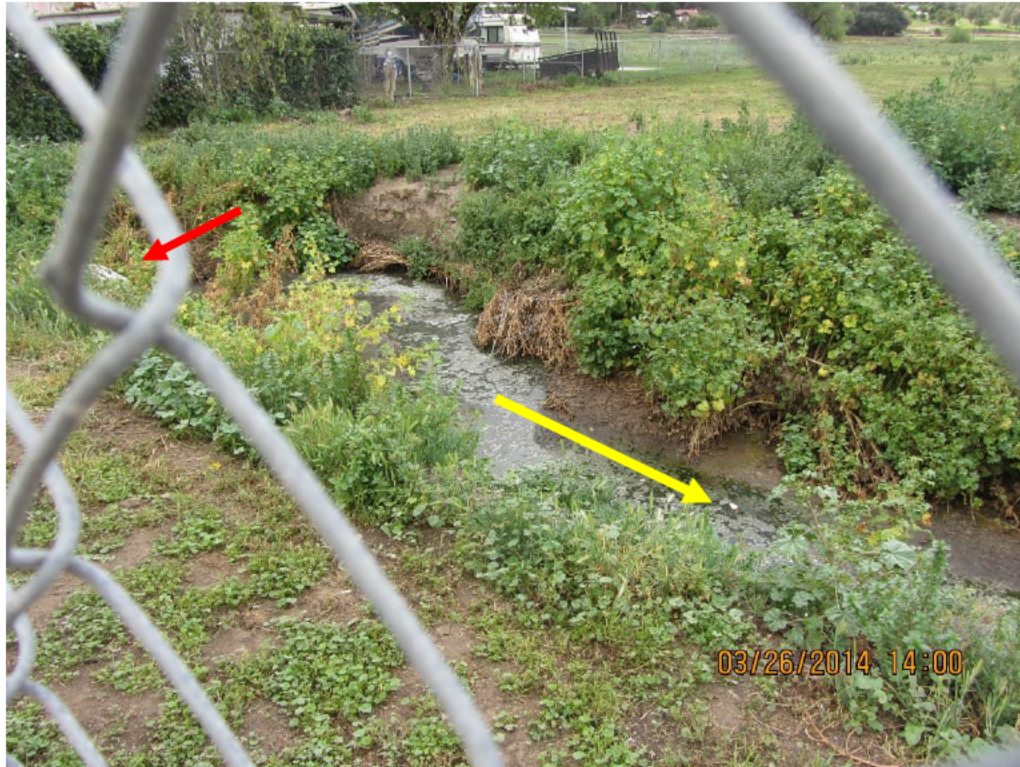
Photo 33 – Water collected in the drainage channel seen in the previous photo. Direction of flow is to the north (yellow arrow). A red arrow marks the outlet of the culvert.

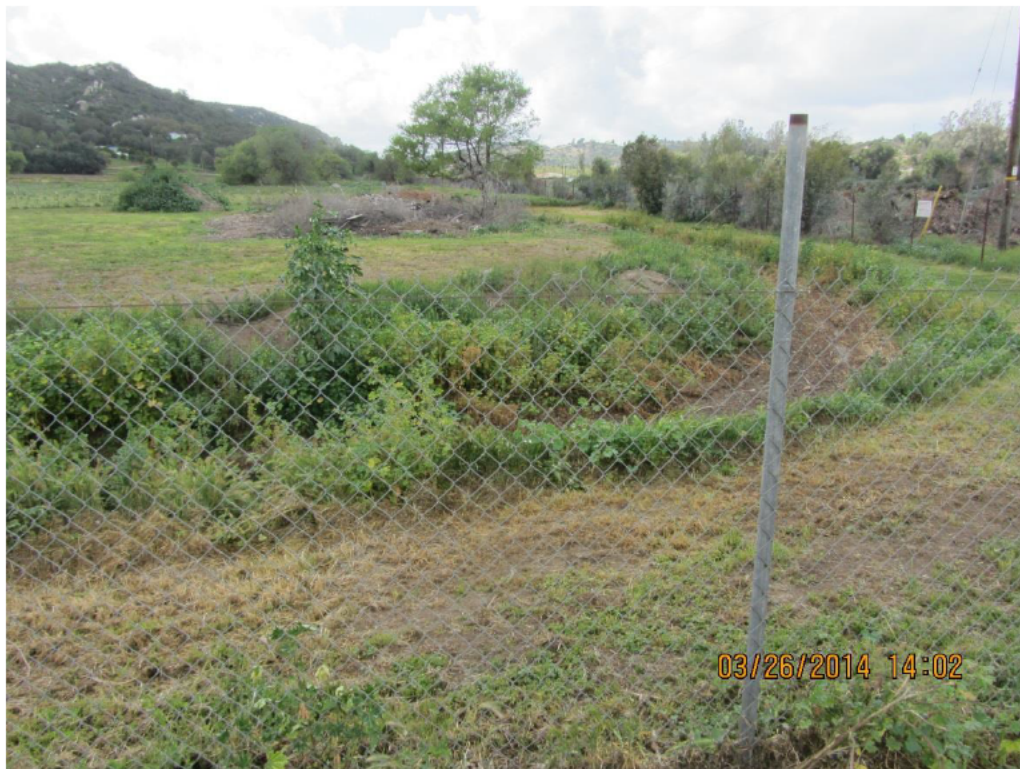
Photo 34 – Continuation of the channel seen in the previous two photos. The channel curves toward the west.

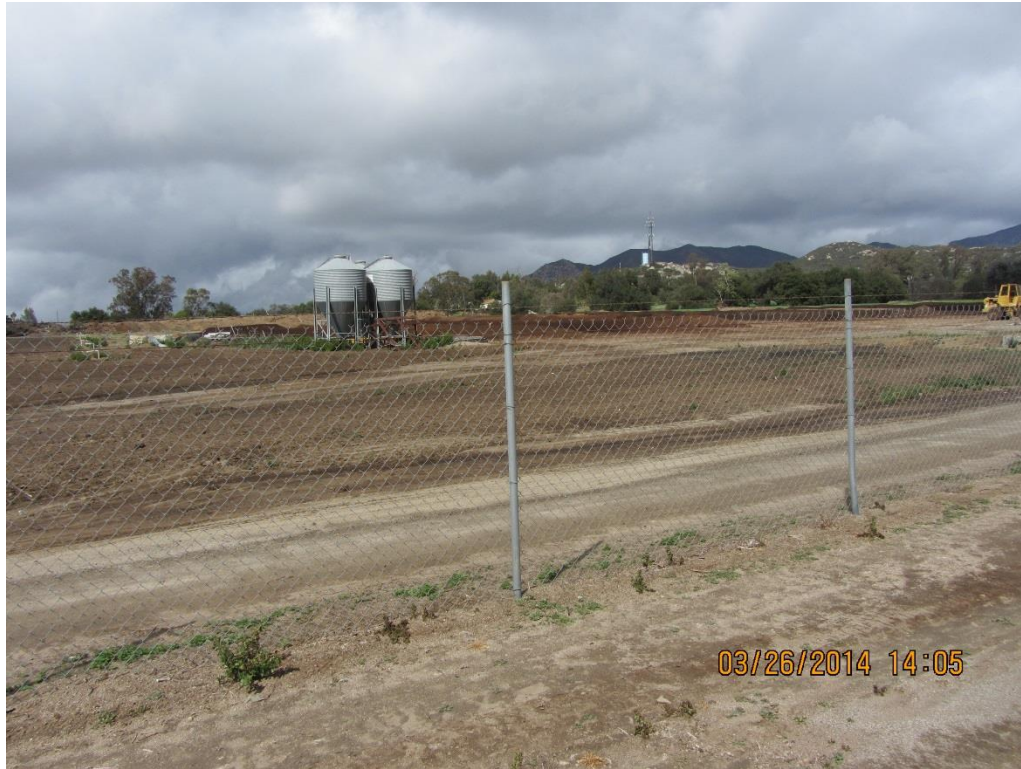
Photo 35 – This area, immediately to the north of the main egg farm, is where Mr. Armstrong reported that he land applies manure. It was not clear where the land application area was. From the south side of the fence and via aerial photography, it appears manure is arranged in rows similar to those in the center of the egg farm.
